Korea Aviation voluntary Incident Reporting System

GYRO

Issue 195

November 2018

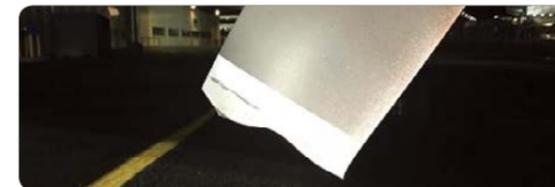
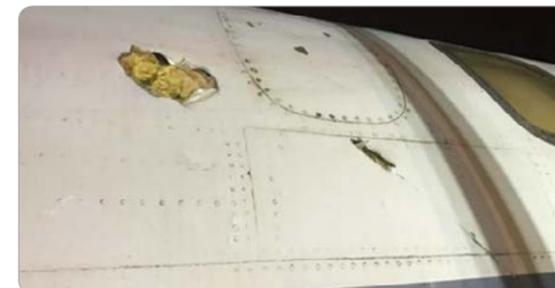
Metroliner Cargo Flight Turns Ugly When Loose Screwdriver Hit Propeller During Takeoff

A Swearingen SA226-TC, N158WA, was substantially damaged due to foreign object damage to the airplane's propeller and fuselage during initial takeoff/climb from Boise Air Terminal, Idaho, USA. According to Federal Aviation Administration personnel, about the time the airplane was rotating from runway 10L, the pilot experienced a light vibration; he subsequently returned to BOI and landed uneventfully. During a post-landing examination of the airplane, it was revealed that a portion of the outboard section of a left propeller blade, which had fragmented into 2 pieces, was missing. Additionally, about a 4 inch by 4 inch puncture hole was observed to have gone through the left forward side of the fuselage just aft of the main air stair door; a piece of the propeller blade was found in the cabin. It was further noted during a runway sweep for foreign objects shortly after the occurrence, that a screw driver which had been used during maintenance on the airplane earlier, and the second piece of the propeller blade tip, were both recovered from the departure runway in the same approximate location from where the airplane would have rotated.

Probable Cause: "Company maintenance personnel's failure to remove a screwdriver that was left lodged in the windshield wiper area of the forward fuselage during maintenance and subsequently became dislodged on takeoff/initial climb and collided with a left propeller blade."

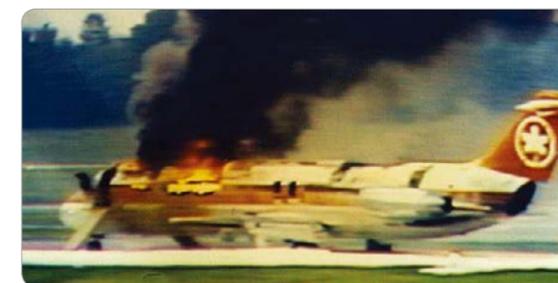
- Air Canada flight no. 797 (1983) - Cincinnati

In the process of an escape after the emergency landing of a DC-9 aircraft owned by Air Canada at Cincinnati Airport due to a fire during the flight, 23 out of 46

passengers were killed due to the rapid expansion of the fire. In this accident, the fire that occurred within the sealed compartment had been expanded by the supplying of oxygen from outside when the door of the aircraft was opened. In relation with this accident, FAA insisted on the installation of smoke detectors and automatic fire extinguishers within the aircraft toilets. Following this, all airliners around the world were required to replace the seats with seats made from incombustible material, and to install a guidance cabin light system to enable escape in an emergency.

- ▶ Influence: Mandatory installation of smoke detectors and automatic fire extinguishers at the lavatory in the aircraft

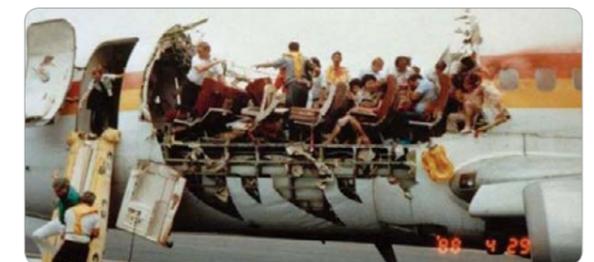
- Aloha Airlines flight no. 243 (1988) - Maui

A B737 passenger aircraft of Aloha Airlines, which lost parts of its body during a flight due to an explosion, landed safely at Kahului Airport. Though one crew member was sucked out of the plane upon the explosion, the rest of the crew and all passengers were safe. US NTSB considered that this was the result of repeated corrosion and the accumulated fatigue during the more than 89,000 flights performed by this aircraft. As a result, the FAA commenced a research program on

old aircraft in 1991 in order to reinforce requirements related to aircraft inspection and maintenance.

► Influence: Reinforcement of requirements on the inspection and maintenance of old aircraft

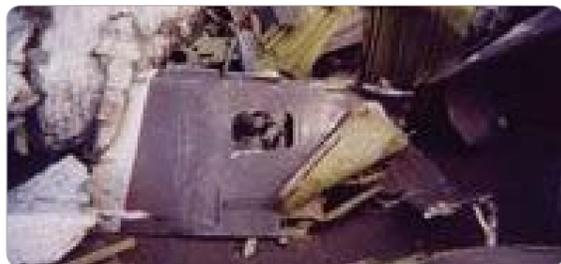
- Swiss Airlines flight no. 111 (1988) - Nova Scotia

An MD-11 passenger aircraft owned by Swiss Airlines that was heading to Geneva fell into the sea, killing 229 – all crew members and all passengers. This accident occurred due to a fire in the cockpit that spread due to presence of combustible material, making control of the aircraft impossible. Sparks from some of the wires at the top of the cockpit caused a fire that spread rapidly, which was determined as the main cause, and so the FAA required that the cockpit material in 700 aircrafts of McDonnell Douglas be replaced with non-flammable material.

► Influence: Mandatory use of insulation for wiring material

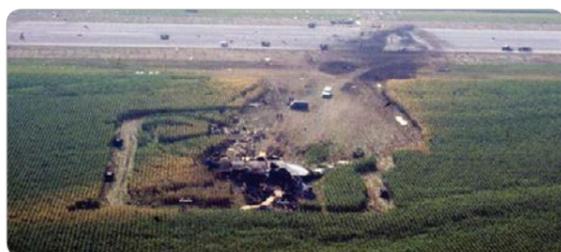
- United Airlines flight no. 232 (1989) – Sioux City

When a DC-10 passenger aircraft owned by United Airlines made an emergency landing at Sioux City after its number 2 engine turned off during the flight, 111 out of 296 passengers were killed. When the engine stopped, the hydraulic system could not be operated, causing this accident. Ultimately, this was traced back to an initial manufacturing problem of titanium alloy, that resulted in the mechanism to

detect the cracking of fan disk in the engine not being activated. The FAA instructed that the hydraulic system of all DC-10 aircraft be amended, and the method of engine inspection was changed as well since the FAA requests a dual safety system on all aircraft being developed in the future.

► Influence: Improvement of engine safety and change in inspection method

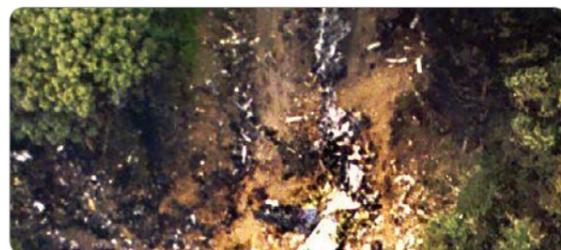
- American Airlines flight no. 427 (1994) - Pittsburgh

A B737 aircraft owned by American Airlines crashed during its landing at Pittsburgh Airport, killing 132 passengers and crew members. This accident had occurred due to a problem with the operation of a rudder, which is one of the control surfaces. An investigation carried out by American Airlines over 5 years found that the cause of this accident was the same as for the accidents involving United Airlines flight number 585 in 1991 (25 deaths) and East-wind Airlines flight number 517 in 1996 (no casualties). In detail, some of the valves of the rudder control system had been blocked, resulting in the rudder being operated in reverse. Following this discovery, the Boeing Company was required to spend 500 million USD to repair the 2,800 B737 aircrafts being operated in the world at that time.

► Influence: Improvement of structural problem on the rudder of aircraft

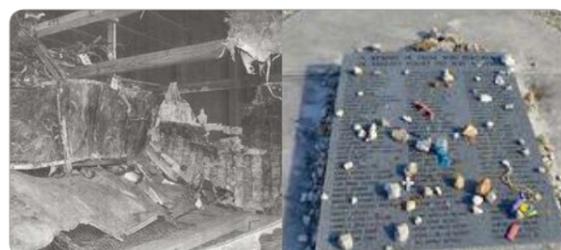
- Value Jet flight no. 592 (1996) - Miami

A DC-9 aircraft operated by Value Jet fell out of the sky due to a fire accident that started in an oxygen container loaded at the cargo bay, killing all 110 passengers. As a

result of this accident, the FAA mandated the installation of smoke detectors and automatic fire extinguishers at the cargo bay of all commercial flights, and reinforced regulations on the transportation of dangerous goods.

► Influence: Mandatory installation of smoke detectors and automatic fire extinguishers at the cargo bay in the aircraft

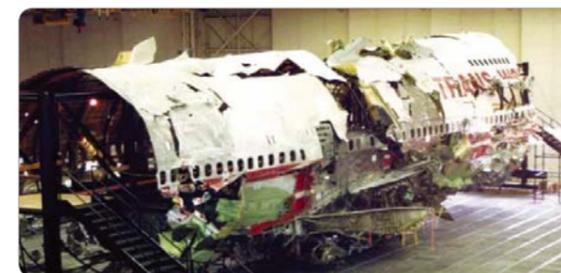
- TWA flight no. 800 (1996) - Long Island

A B747 passenger aircraft operated by TWA that was heading to Paris exploded right after taking off from JFK Airport in New York, killing all 230 passengers. Initially suspected as an act of terrorism, an investigation found that a defect in the central fuel tank was the cause. The fire had occurred due to an electric spark near the fuel tank for the central wing, so the FAA instructed that the wiring design structure near the fuel tank be changed. As the same time, the Boeing Company developed a fuel inactivation system, in which nitrogen gas is injected into the fuel tank in order to reduce the possibility of an explosion, and installed this in all aircraft it developed moving forward.

► Influence: Change of wiring design near the fuel tank (Prevention of electric spark)
