Korea Aviation voluntary Incident Reporting System

GYRO

Issue 195

November 2018

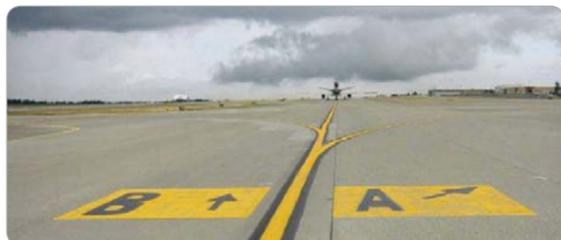
Unauthorized Entry On Taxiway

At that time, I was serving as co-pilot, and after push-back at Narita Airport, I had been taxiing into runway 16R for take-off as assigned. At the ground, the captain takes charge of control while I as the co-pilot was in charge of ATC and handling of equipment. After we had been assigned route 1, a ground route for departing from Narita through S8 Gateway, when we were taxiing as specified in the chart, there was a situation that required us to change the taxiway for re-assignment due to a mistake regarding the taxiway. It was the correct procedure to enter from TXYC by passing S1 and taking a right turn on W to enter W, and we had even mutually confirmed in call-outs among crew members that we were "Approaching S1, Next W," and we had gone straight at ABEAM S1. Then, when we reduced the speed of the airplane and took a right turn toward S1 Gateway about 45 degrees, we had realized that we had made a wrong entry, so we stopped immediately. At that time, it was impossible for us to proceed to the right route toward W direction due to the position of the airplane being stopped. When I prepared to talk about the situation to ground control, I first heard the assuring message from the ground "HOLD POSITION I UNDERSTAND YOUR SITUATION" and then "REVISE YOUR TAXI, RIGHT TURN ON S8 GATEWAY, LEFT TURN W9, JOIN W, THAN ROUTE 1." So, we were able to join the normal route 1 from close by the taxiway, and fortunately there was no other traffic nearby, so we could taxi without any problems for taking off.

The Narita Airport has a relatively complex structure in comparison with other airports, so the information about the airport must be sufficiently understood in advance. Moreover, the classification of taxiway, etc. is not so easy in comparison with the complexity of structure, and thus it requires attention.

First of all, based on the contents of this report, it seems like that there was insufficient CRM. It is considered that there was a failure to confirm whether the taxiing has proceeded in accordance with the instructions of the control tower, through continuous conversation with the co-pilot.

Second, there was insufficient preliminary preparation by the pilot. It seems that the pilot failed to make sufficient preparations, such as confirmation of the preliminary information, etc. about the relevant airport through charts, etc. In particular, it is essential to ensure one has sufficient information about the airport in advance at a relatively complex place like Narita Airport.

Finally, there seems to be no education or training for pilots that will enable them to recognize the situation. Domestically, training is mainly about emergency situations, and landing / taking-off training, and there is almost no training on taxiing.

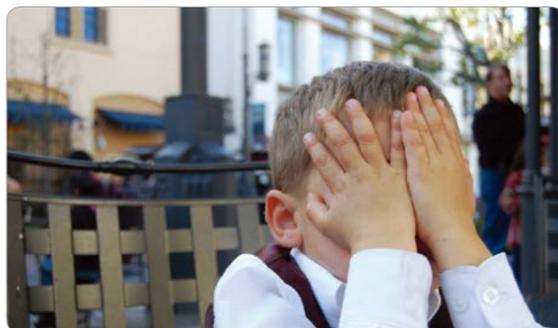
Course Deviation Due To Misunderstanding Of Instruction By Control

At the time of flight, we were approaching a Visual RWY34 at Fukuoka Airport. We had been approaching in normal descent angle around 1,000 Ft. of FINAL RWY 34, but had gone below the normal descent angle, and so we had initiated the go-around based on the advice of PM. After the completion of initial control of go-around, TWY Control told us "RWY HDG CLIMB 3,000FT" but we were already heading 3,000FT, and again, the TWY Control told us to maintain 3,000FT, but at this time the airplane was already heading 3,500FT. PF had converted to manual operation for a prompt descent to 3,000FT and had controlled to maintain 3,000 FT, and then TWY Control had transferred to DEP Control. Upon making contact with DEP Control, PM reported "MAINTAIN RWY HDG, 3,000FT" and after PM heard "DRT DGC77 CLIMB & MAINTAIN 4,000FT," PM had entered FMS after obtaining the consent of the pilot. However, in our confirmation afterward, it was confirmed that DEP Control had instructed "DRT DGC VOR". At that time, PM had concentrated on the manual operation of PF, altitude adjustment, and Flap speed limit monitor, and had recognized the instruction of DEP Control as "DGC 77" instead of "DGC VOR". This misunderstanding of the instruction from the control is considered to have occurred due to the strong expectation that the instruction from control would let the plane into the pattern based on the traffic. After that, it was transferred back to the approach and the App Control had instructed "HDG 270 CLIMB & MAINTAIN 5,000FT" upon the report of "DRT DGC77 CLIMB & MAINTAIN 4,000FT". Then, we approached again to Visual RWY 34 with radar vector, and made a normal landing for the second time.

It is considered that this case complexly combines 3 big issues. First, it seems that the preliminary knowledge of the Fukuoka Airport Chart was insufficient. It seems that DGC77 is a waypoint that does not exist in the official chart, and even though there were contents not listed in the chart among the instructions from control, it seems like there was a failure to make the correct recognition. Second, there seems to be a communication problem between the controller and pilot. From the perspective of the pilot, even though it was the situation to consider that the control instruction had not been clearly delivered, the pilot had controlled the flight as the pilot expected, and there was no confirmation from the pilot or controller regarding the relevant contents.

Finally, there was an issue of whether there was normal performance of control and operation work. Based on the contents of the report, the late instruction by the controller is one of the causes of the altitude deviation, and it is considered that the route

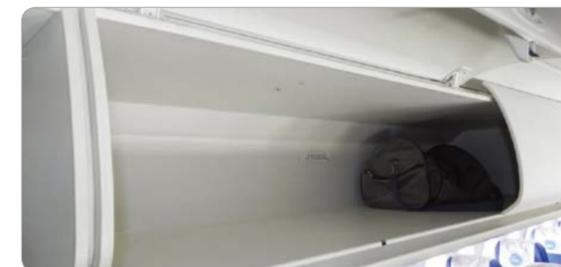
Baggage Management Within The Cabin

1. A passenger sitting at the bulk head seat placed baggage that seemed to be a laptop computer on his knee during take-off instead of putting it in the overhead bin. If there is an escape attempt in the event of an emergency situation, it is considered that this could lead to a big accident. I inquired to the head office, but I received the reply that there is no size limitation on baggage carried by passengers in the front seat.

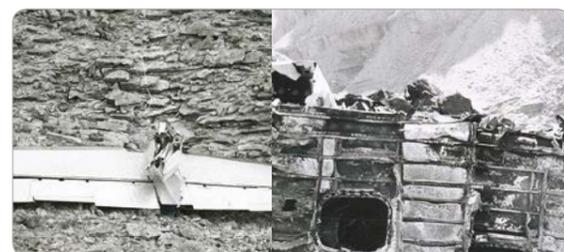
- Air collision accident of aircraft (1956) - Sky over Grand Canyon

A Super Constellation aircraft of TWA (002) and DC-7

aircraft of United Airlines (718) collided in the sky over the Grand Canyon, and 128 people – all passengers on both aircraft – were lost. This accident led the US government to make an investment of 250 million USD in upgrading the entire ATC system. Ever since, there have been no air collisions between two large aircrafts in the USA. Furthermore, this accident led to the establishment of the FAA (Federal Aviation Agency) in 1958. Unfortunately, in 1986 there was another air collision accident in which 86 people were killed, which was a collision between a small plane called a "Piper PA-28" and a large aircraft. As a result of this accident, a law was made requiring small planes to be equipped with a Transponder, enabling the development of TCAS (traffic collision avoidance system).

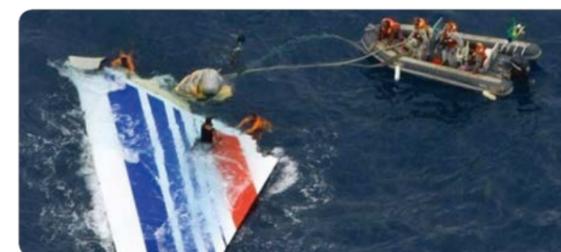
- Air France flight no. 447 (2009) - Atlantic Ocean between Rio and Paris

An A330 passenger aircraft operated by Air France that was heading to Paris from Rio de Janeiro fell into the Atlantic Ocean, killing all 228 passengers. The automatic flight control system had been suspended due to a

problem with the speedometer, after which the co-pilot made a mistake that resulted in an engine stall.

► Influence: Reinforcement of manual operation training in order to reduce the dependency on the aircraft's automated system

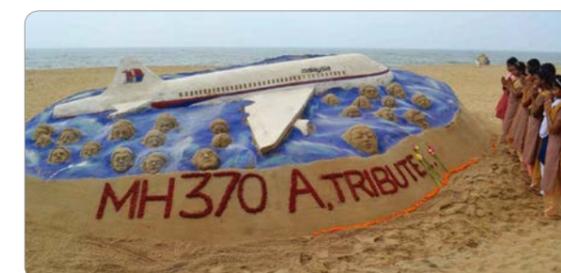
- Malaysia Airlines flight no. 370 (2014) - Presumed in the Indian Ocean

A B777 passenger aircraft operated by Malaysia Airlines that was heading to Beijing in China went missing after leaving Kuala Lumpur. 17 days after the accident, the aircraft had been presumed to have fallen at the southwest of the Indian Ocean, but the exact location and cause was unknown. As of the present time in 2018, the aircraft has still not been found, and all 239 crew members and passengers are presumed to have been killed. If the real-time tracking device suggested after the accident of Air France flight no. 447 had been attached, it is considered that the plane could have been found even after the accident. There is a growing consensus worldwide on the need to develop real-time tracking devices for aircraft.

► Influence: Showing the necessity of a real-time tracking system for aircraft
